**TRANSPORTATION SCIENCES
CRASH DATA RESEARCH CENTER**

Veridian Engineering
Calspan Operations
Buffalo, New York 14225

**CALSPAN ON-SITE AIR BAG RELATED CHILD FATALITY INVESTIGATION
CALSPAN CASE NO. CA96-010
VEHICLE - 1996 DODGE CARAVAN SE
LOCATION - TENNESSEE
CRASH DATE - 1996**

Contract No. DTNH22-94-07058

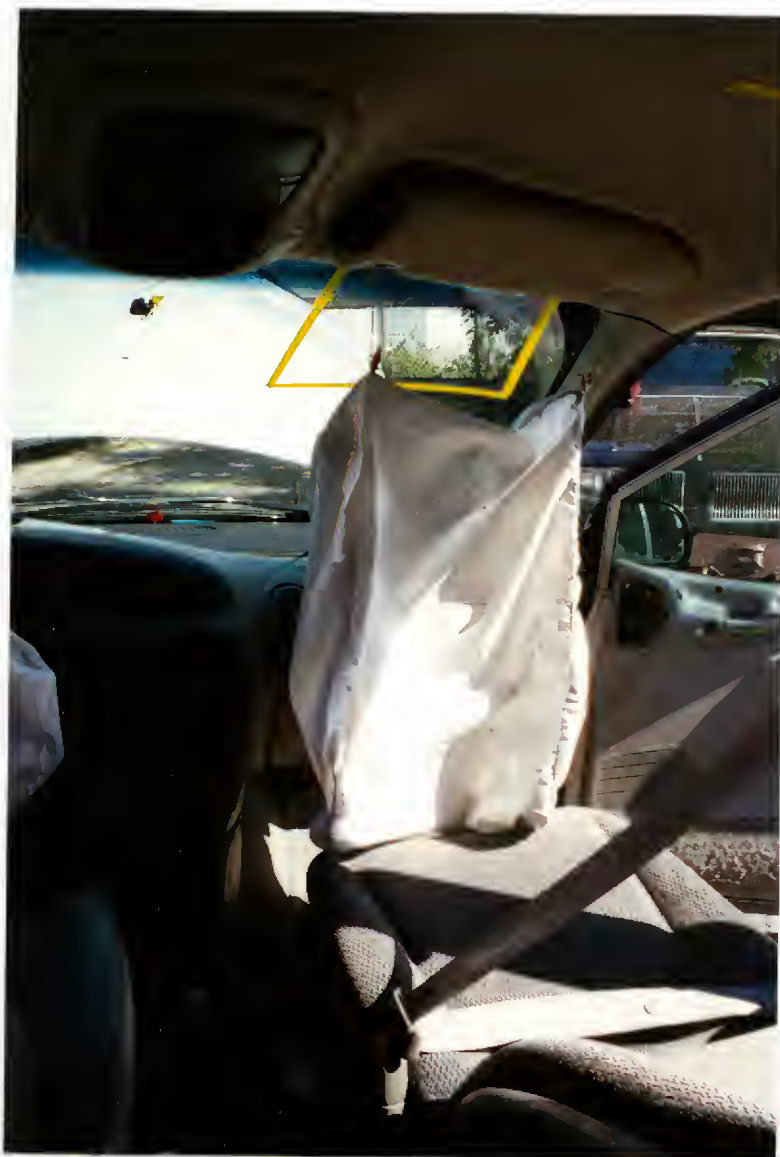
64. Overall front view of the passenger side air bag.

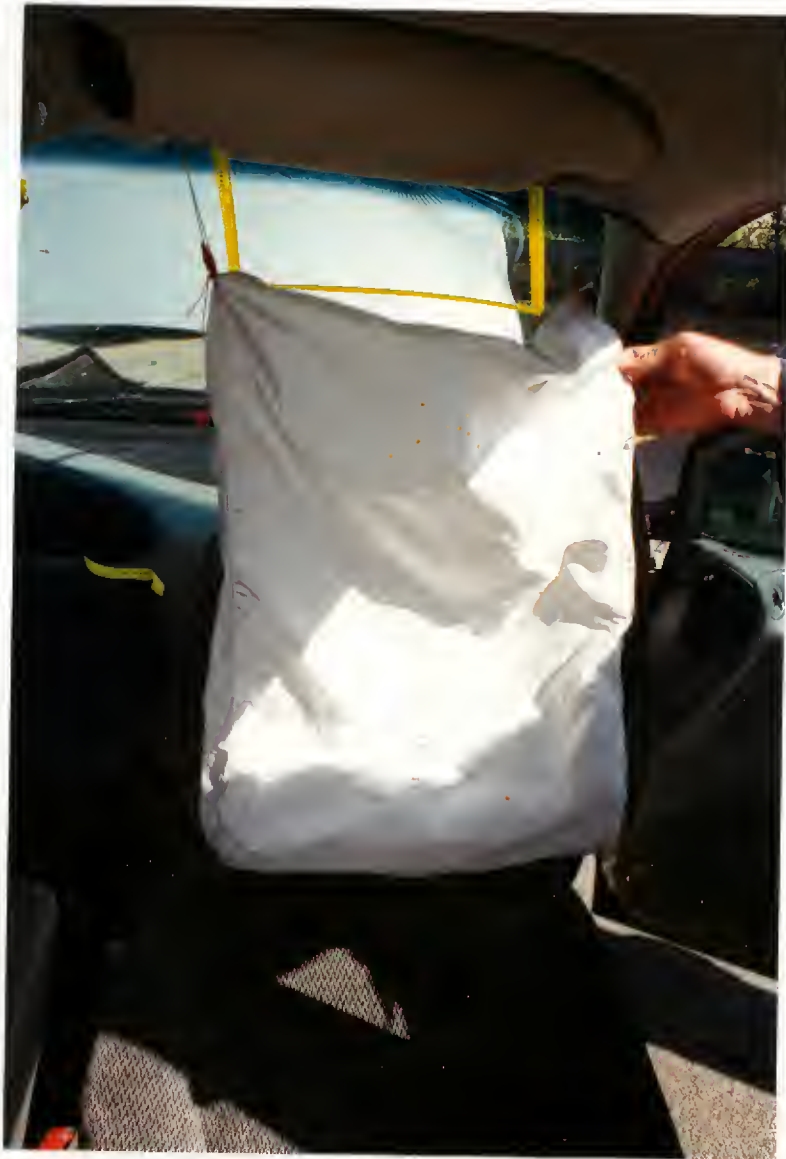
69. Overall view of the face of the passenger side air bag.

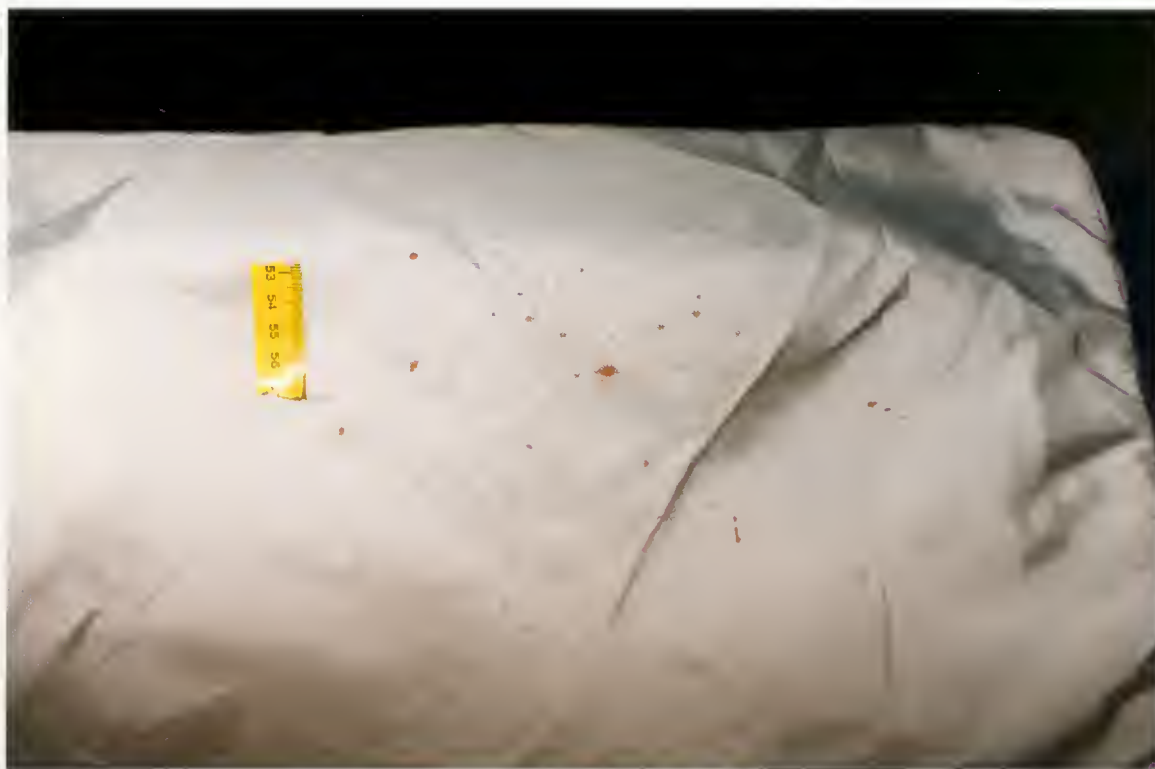
At impact with the Mercury Cougar, the Caravan's frontal air bag system deployed. The expanding passenger air bag membrane impacted the child's face which resulted in superficial abrasions of the forehead and left face, distal to the eye. The expanding air bag contacted the mouth area of the child which resulted in a lacerated lip, an avulsion of a front tooth, and dislocation of several additional teeth. The avulsed tooth was found on the upper instrument panel forward of the steering assembly. Several blood spatter patterns were noted to the bag that may have been related to the avulsion, however, these spray patterns appeared to have occurred from the expulsion of blood during breathing.

71. Close-up view of the blood spatters at the 12 o'clock position.

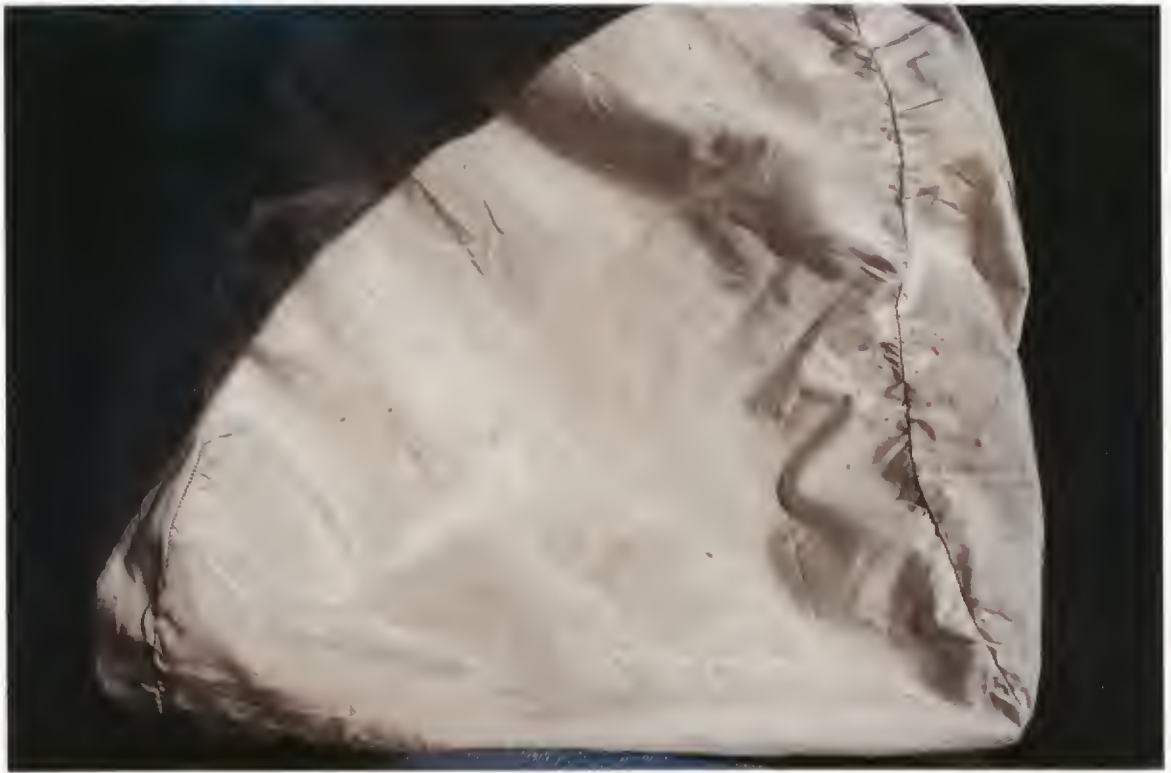
73. View of the lower portion of the face of the passenger air bag.

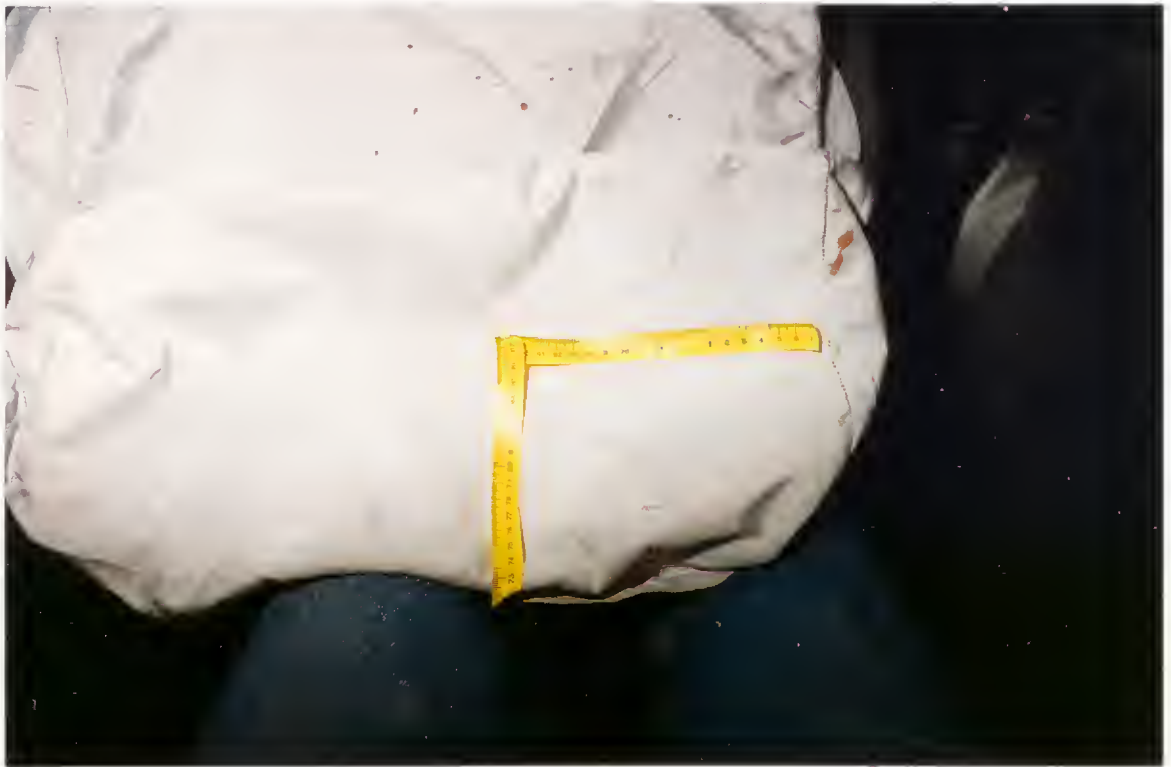
74. View of a gray vinyl transfer on the lower left quadrant of the air bag.

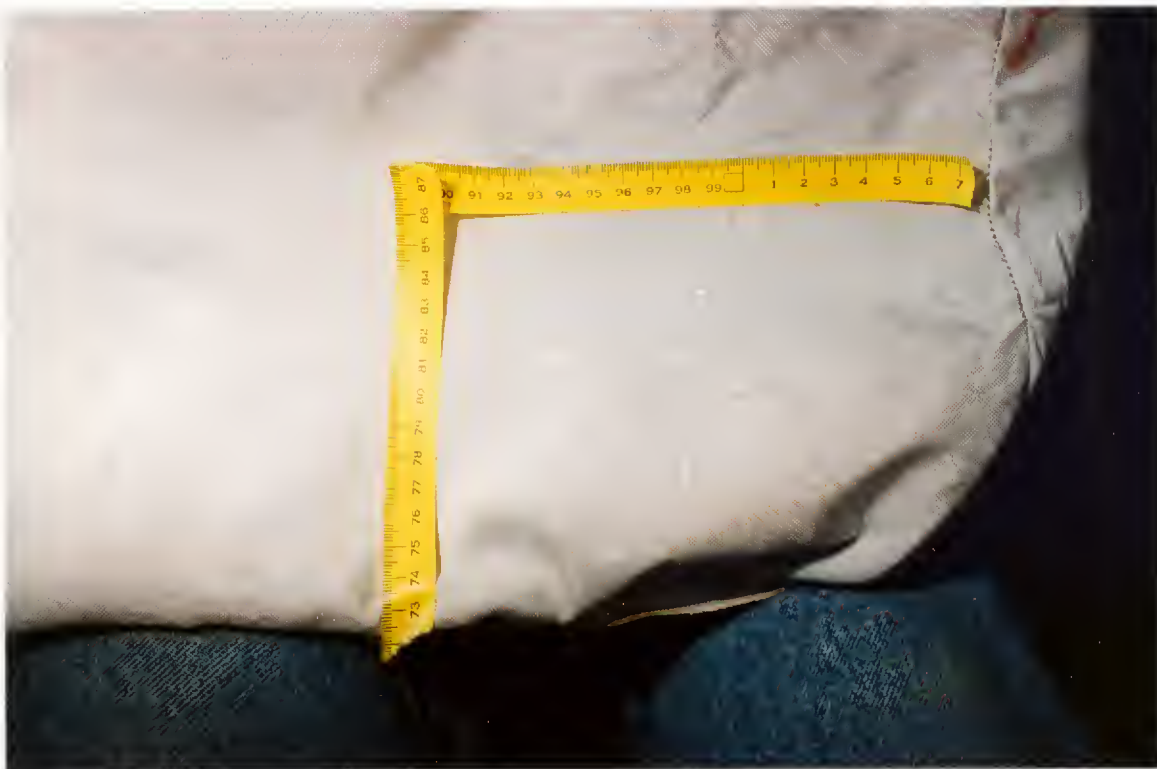
75. Close-up view of the vinyl transfers.

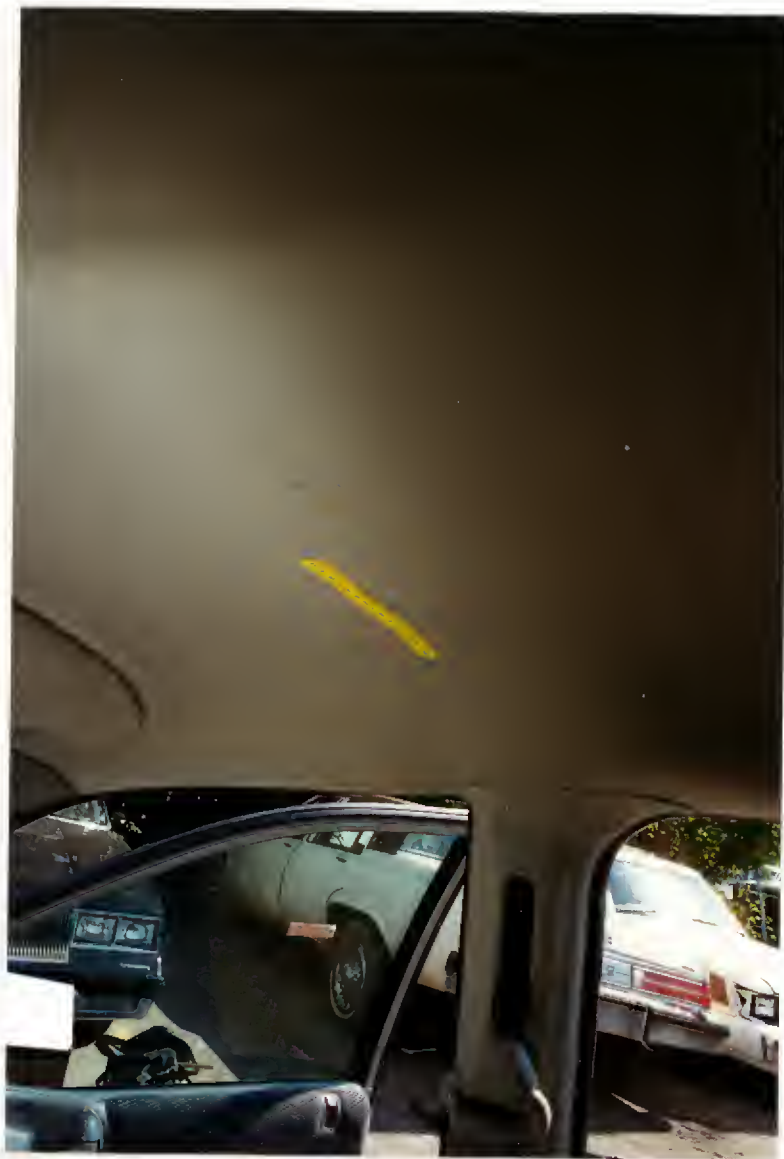
77. View of the headliner above the right front occupant's seat.

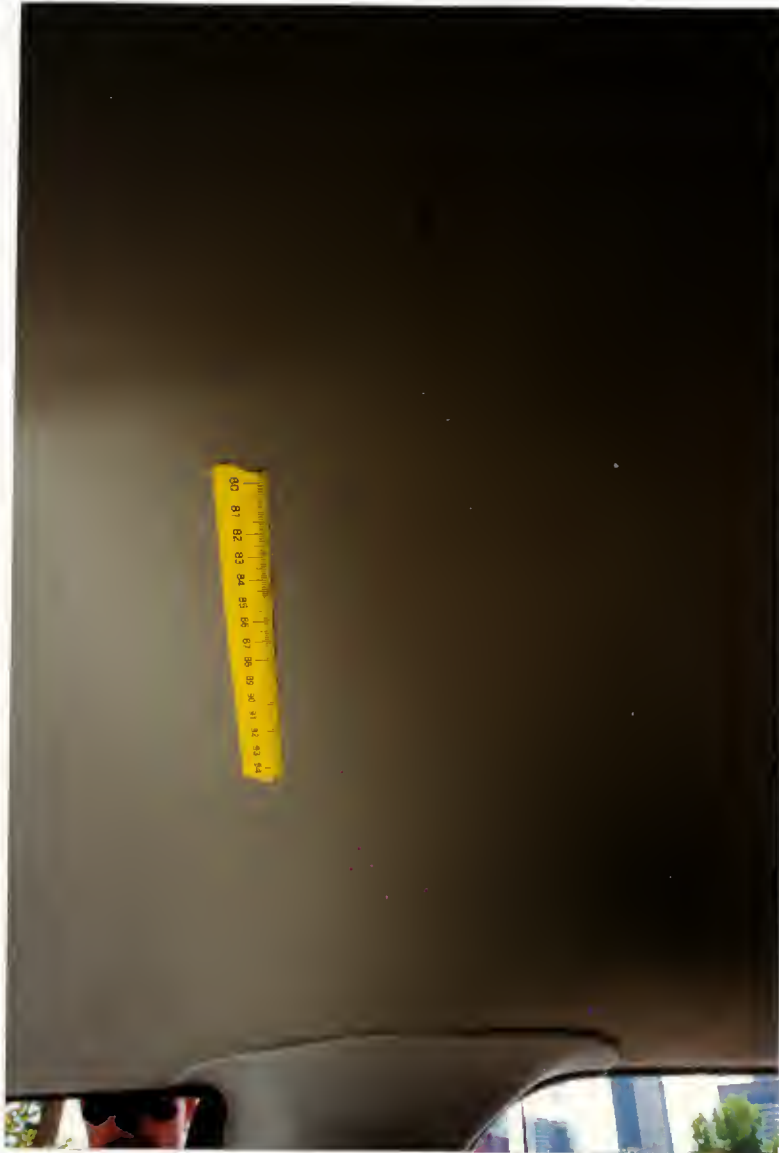
78. Close-up view of the blood spatters on the headliner.

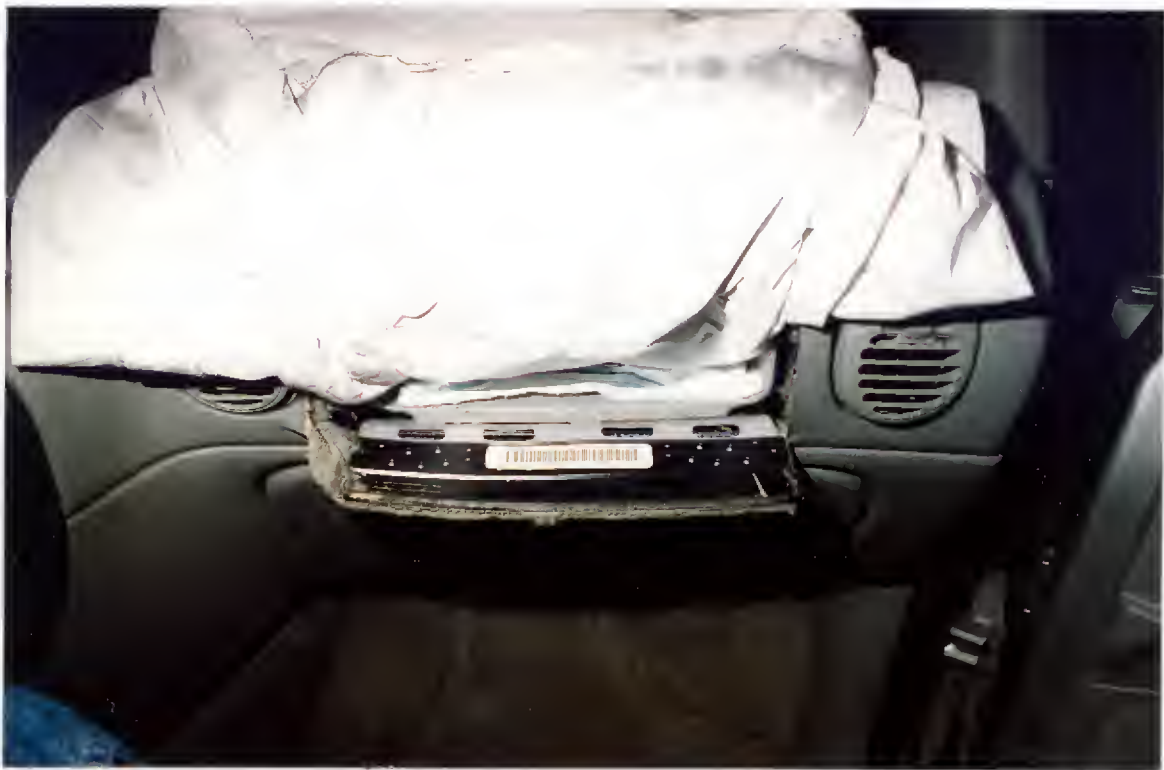
80. View of the lower passenger side air bag module cover flap.

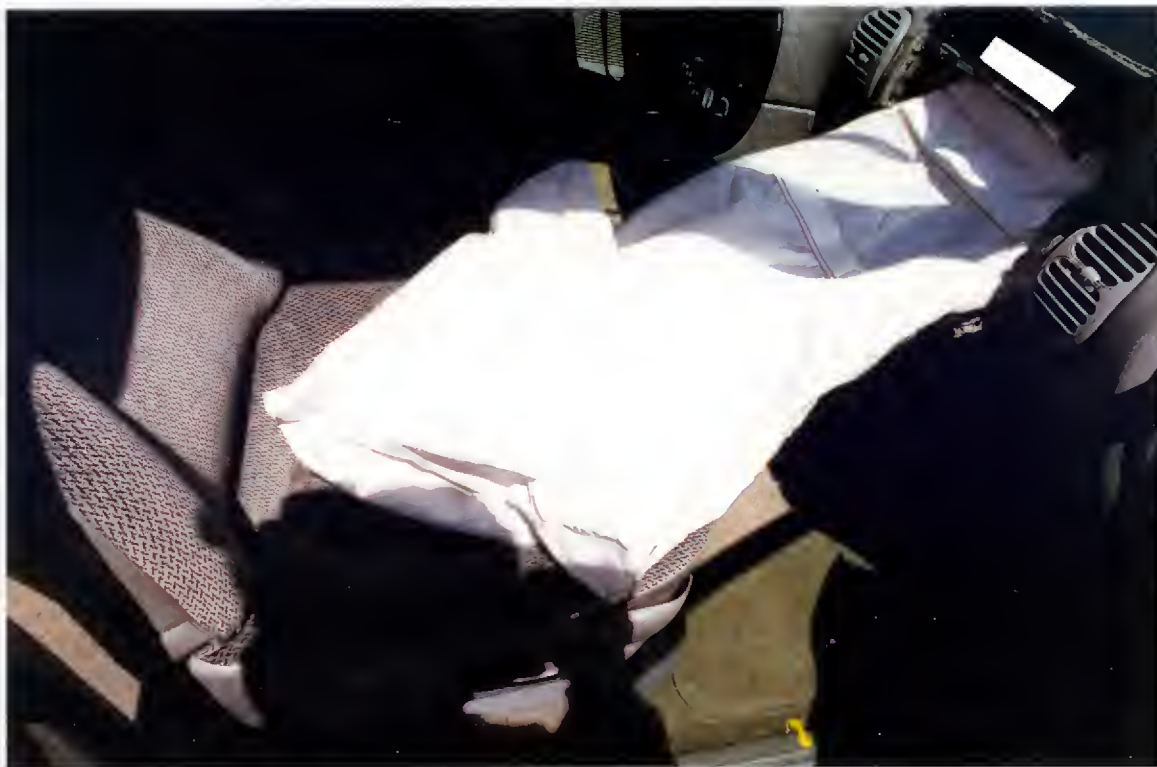
81. Right view of the extended passenger side air bag.

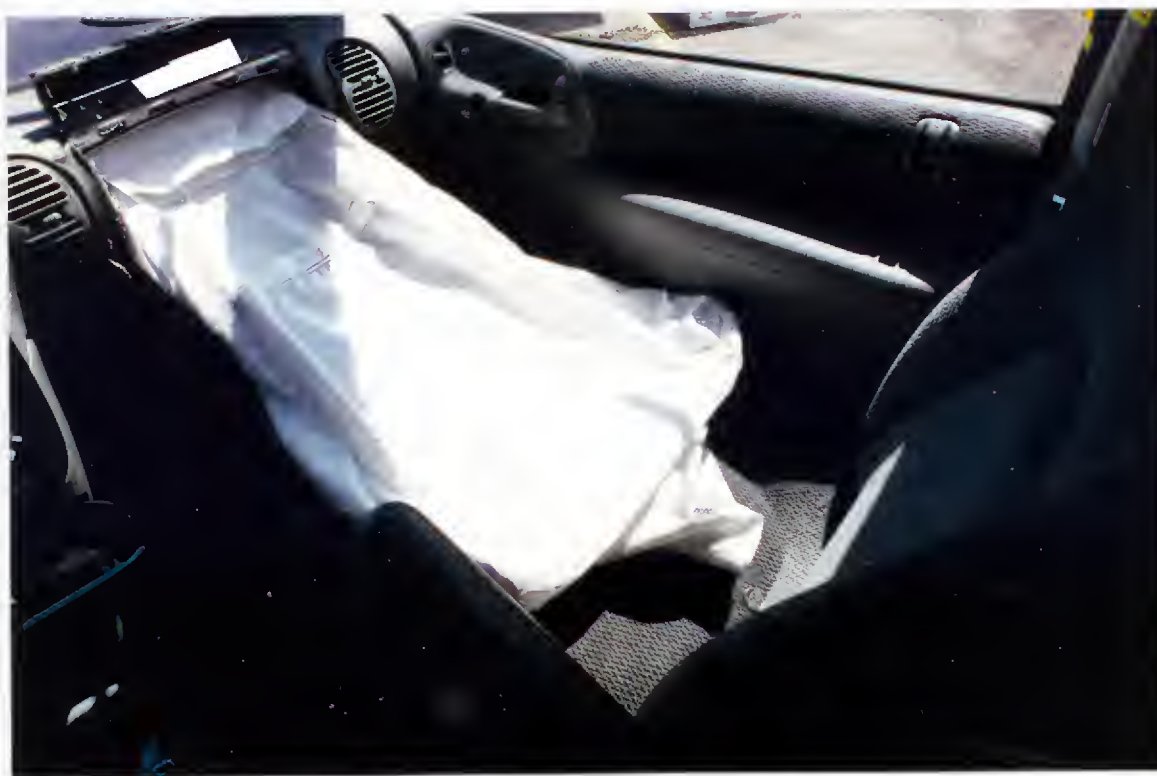
82. View of the rearward extension of the passenger side air bag.

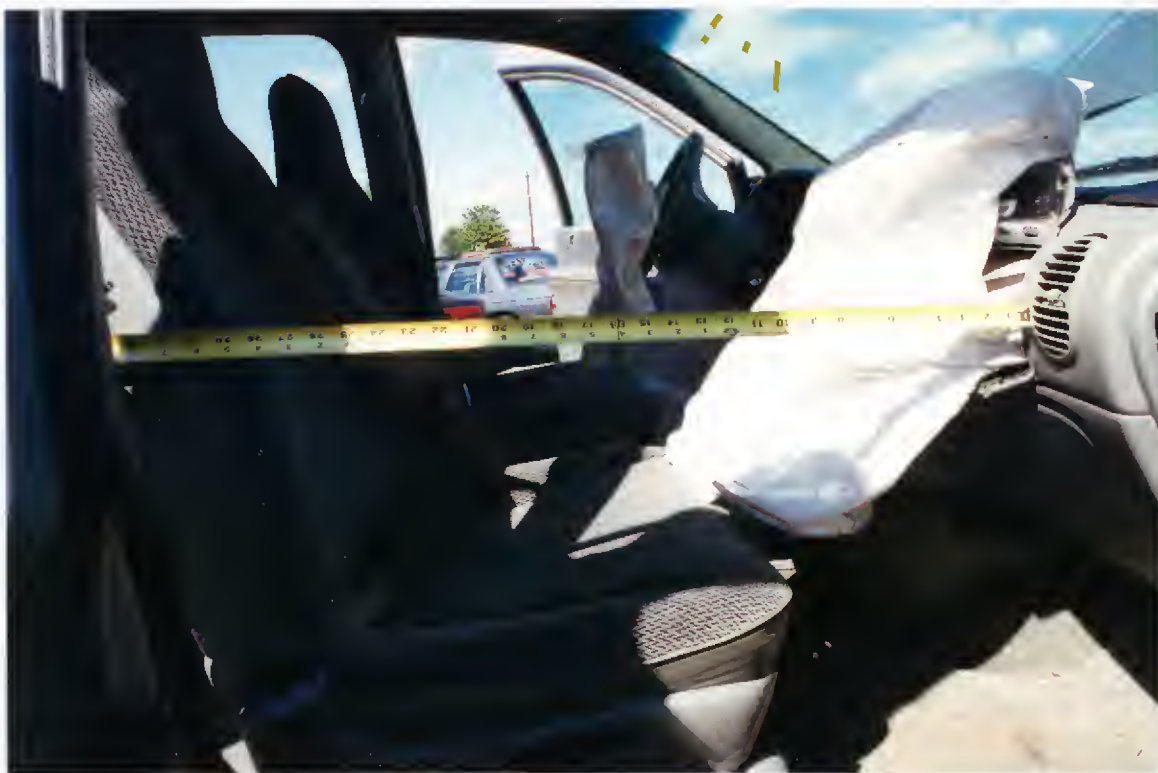
83. Longitudinal measurement of the position of the seat relative to the instrument panel.

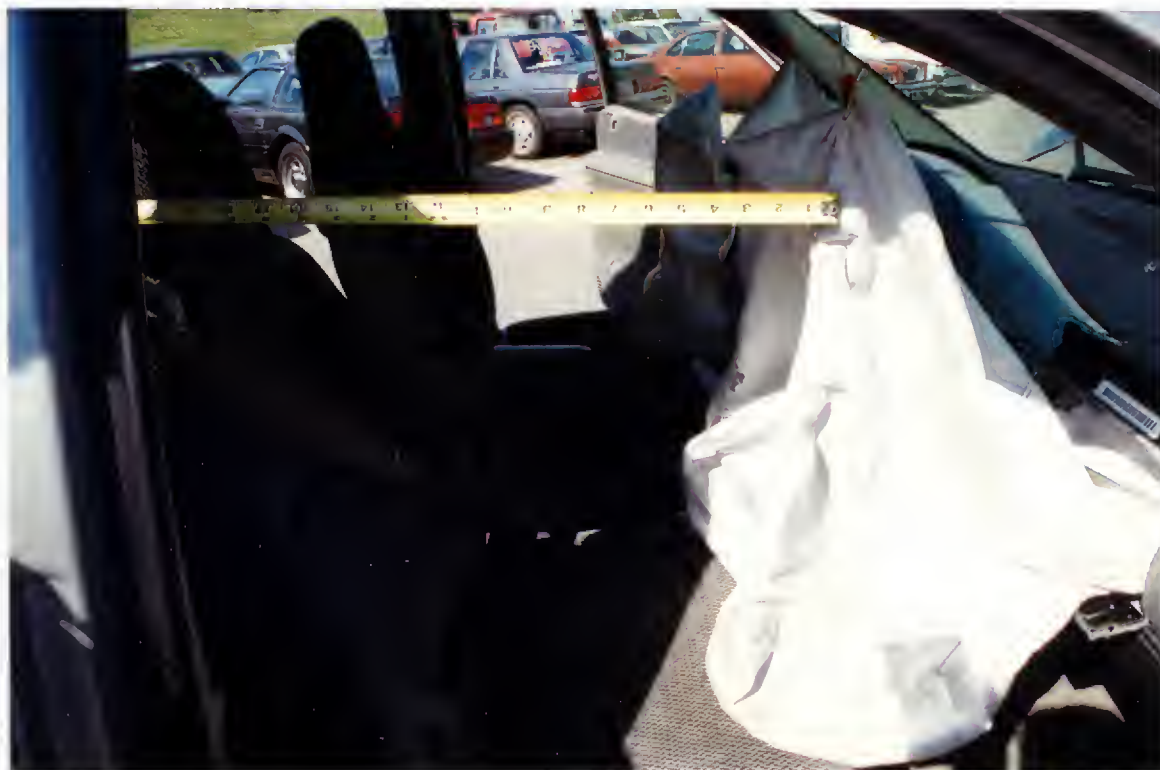
84. Longitudinal measurement of the seat relative to the deployed passenger side air bag.

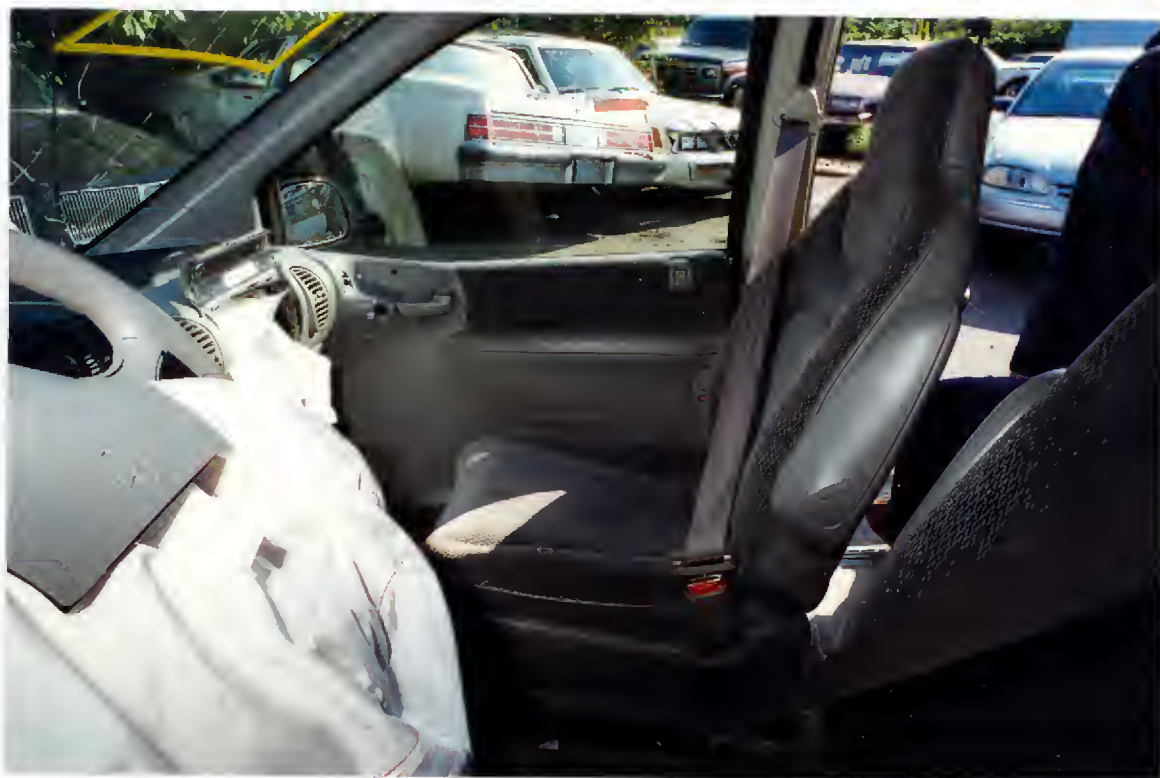
85. View of the right front seat location.

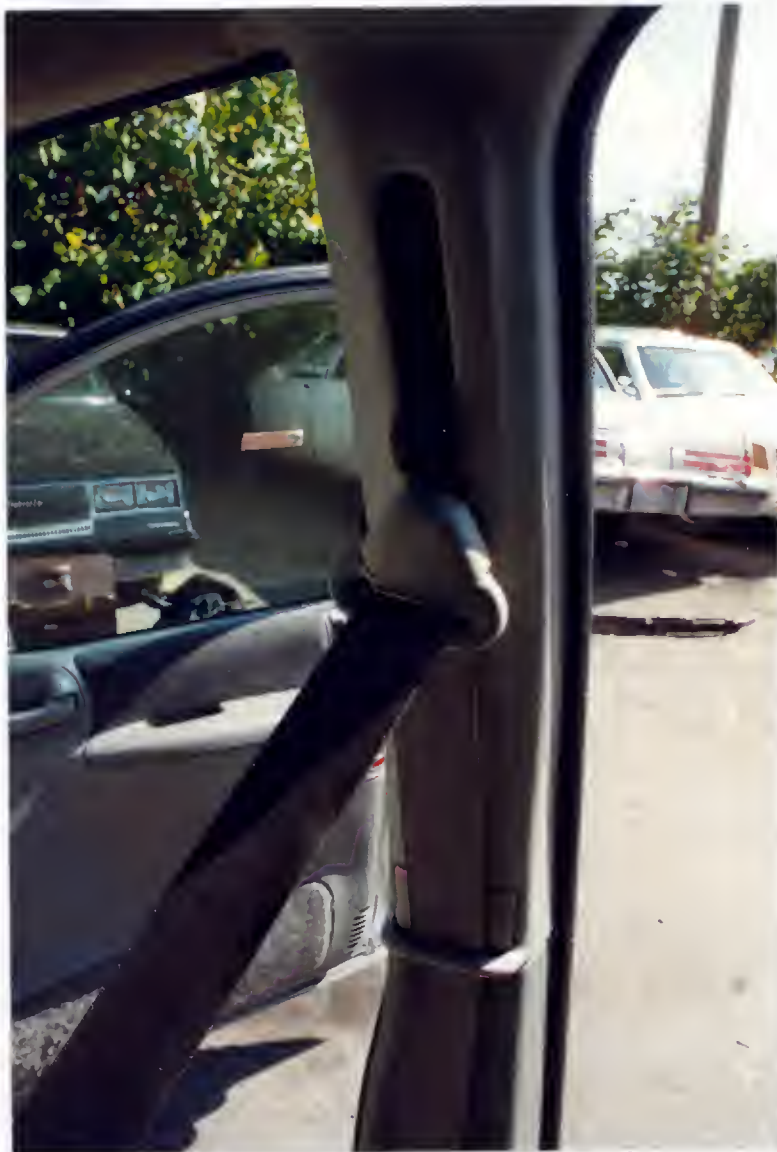
86. View of the right front D-ring location.

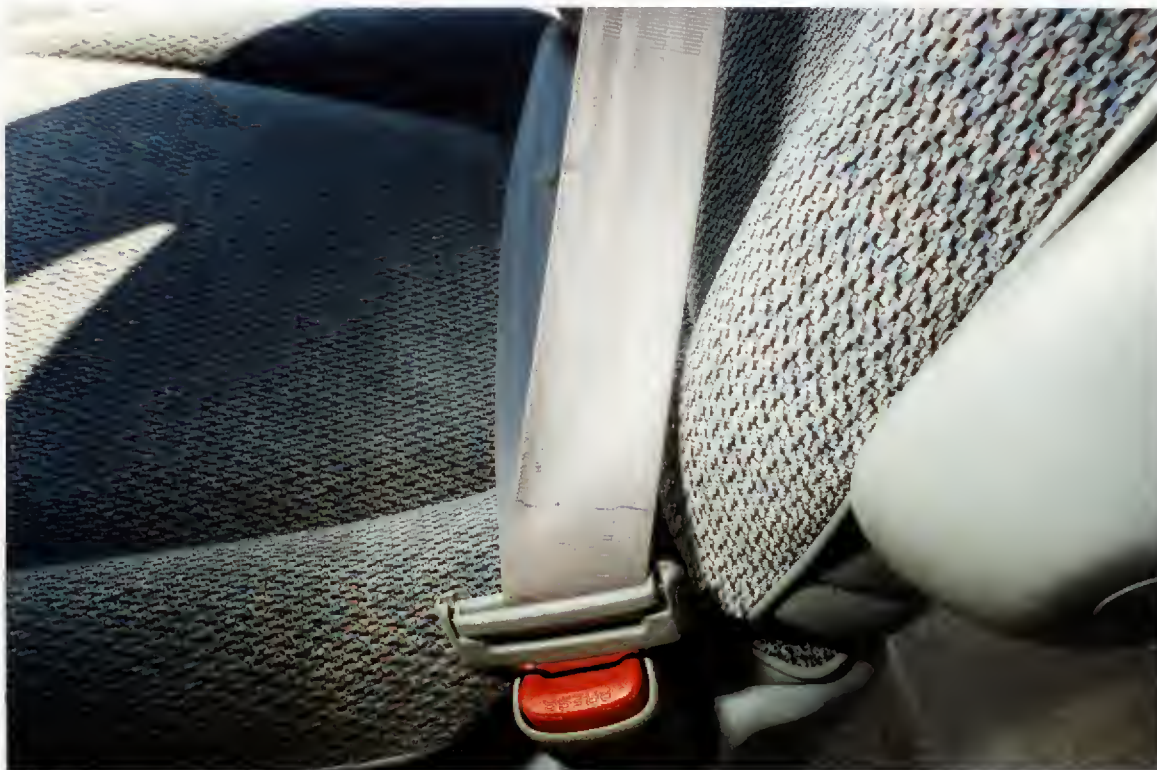
87. View of blood spatters on the right front restraint webbing.

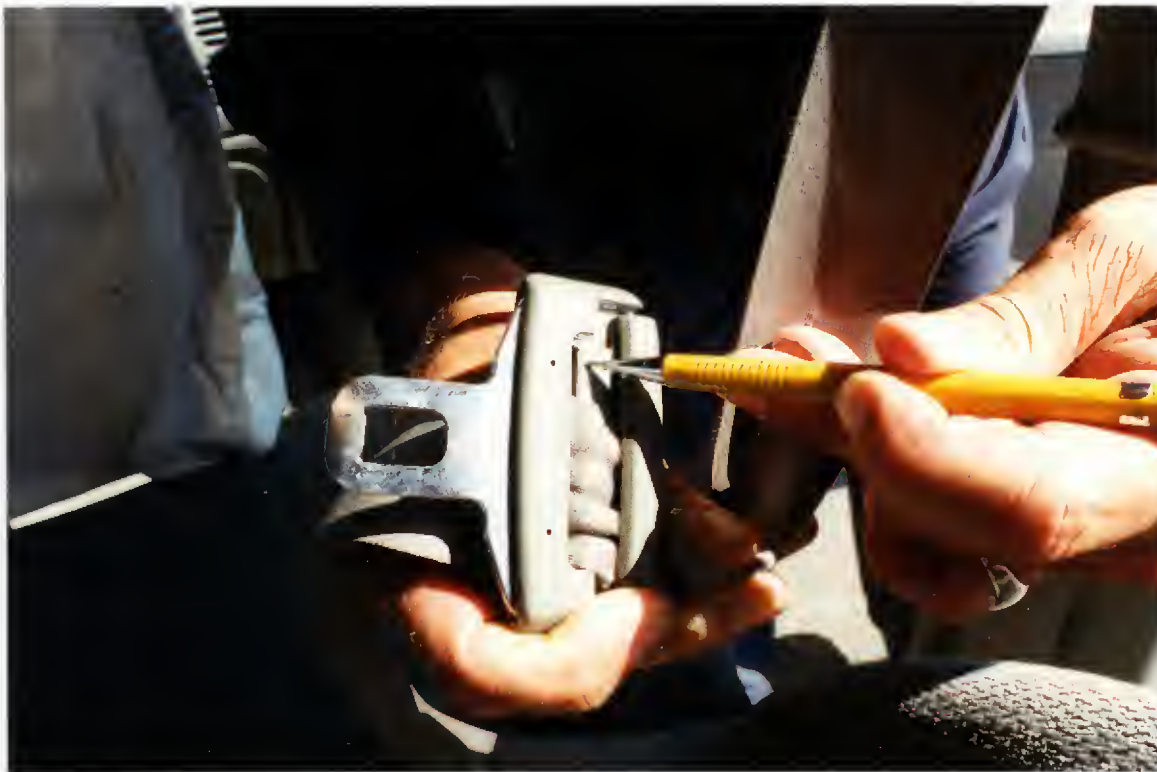
88. View of the abraded plastic on the right front latch plate.

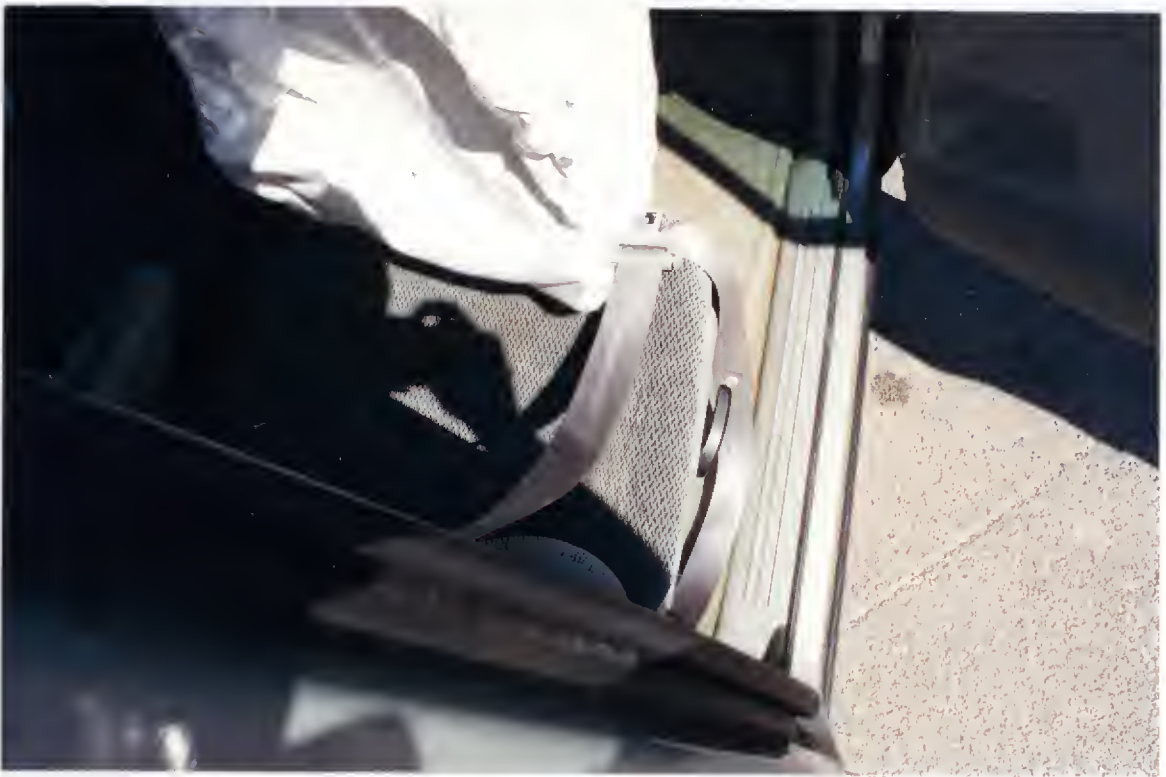
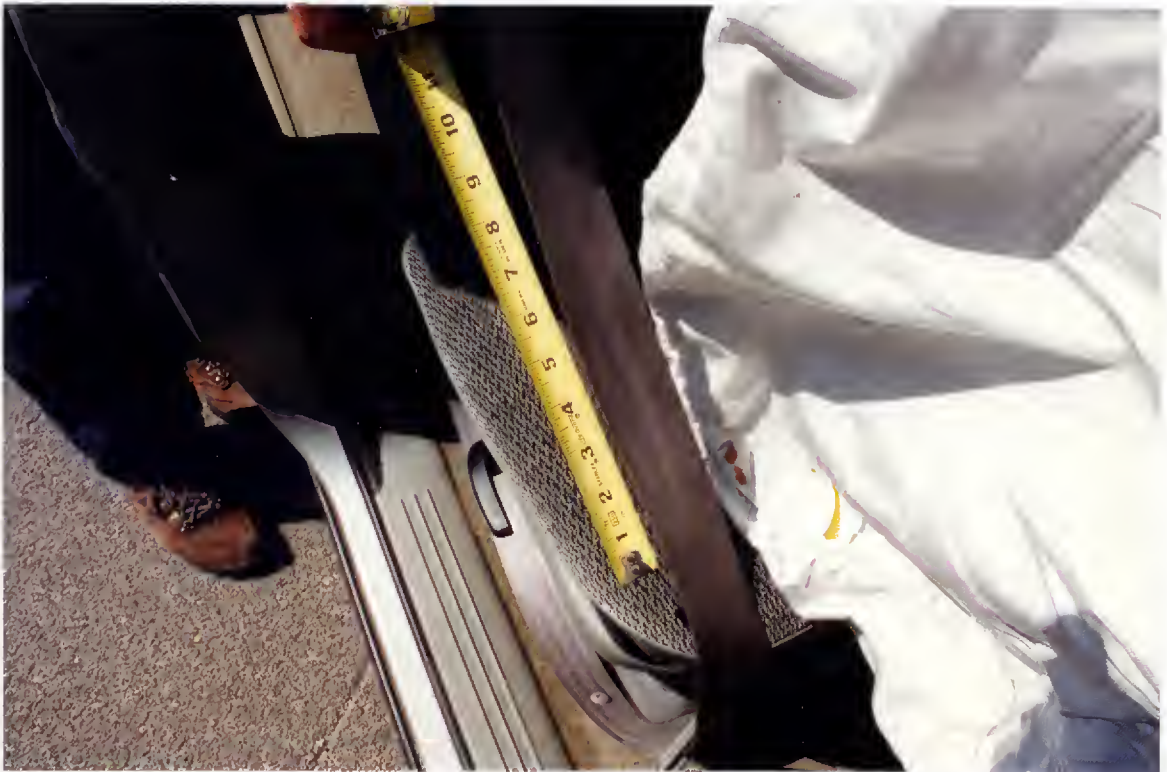
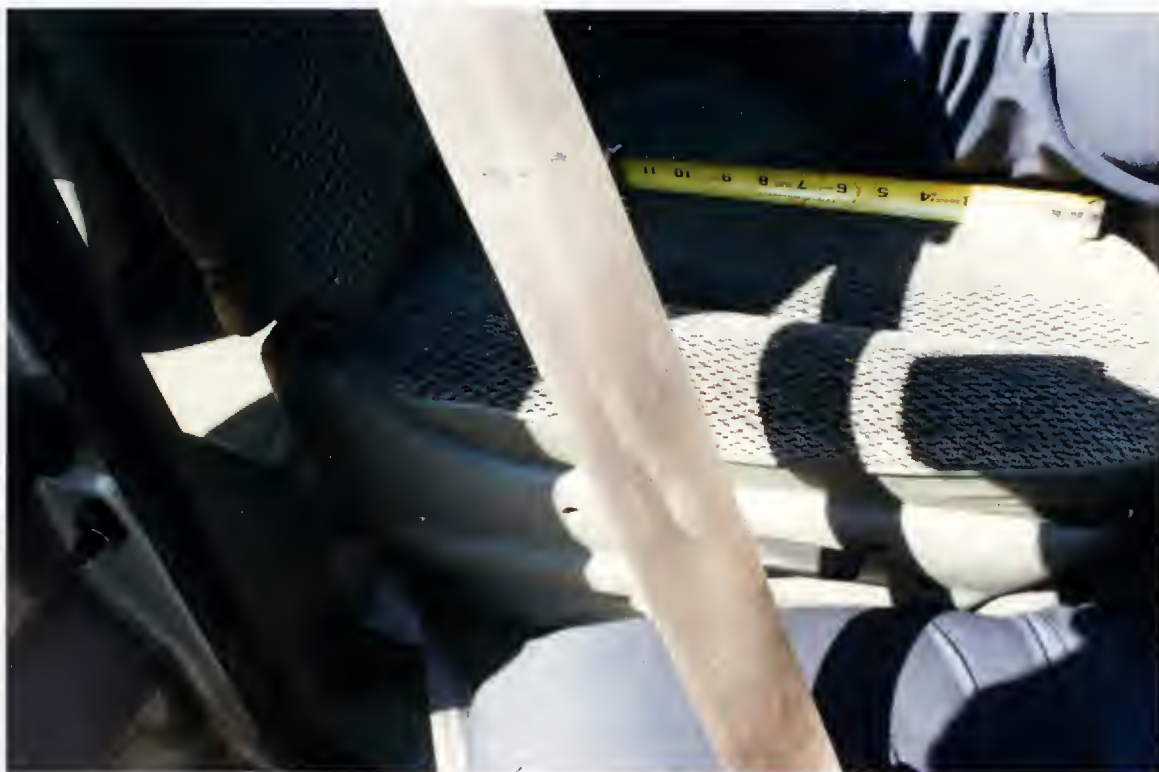
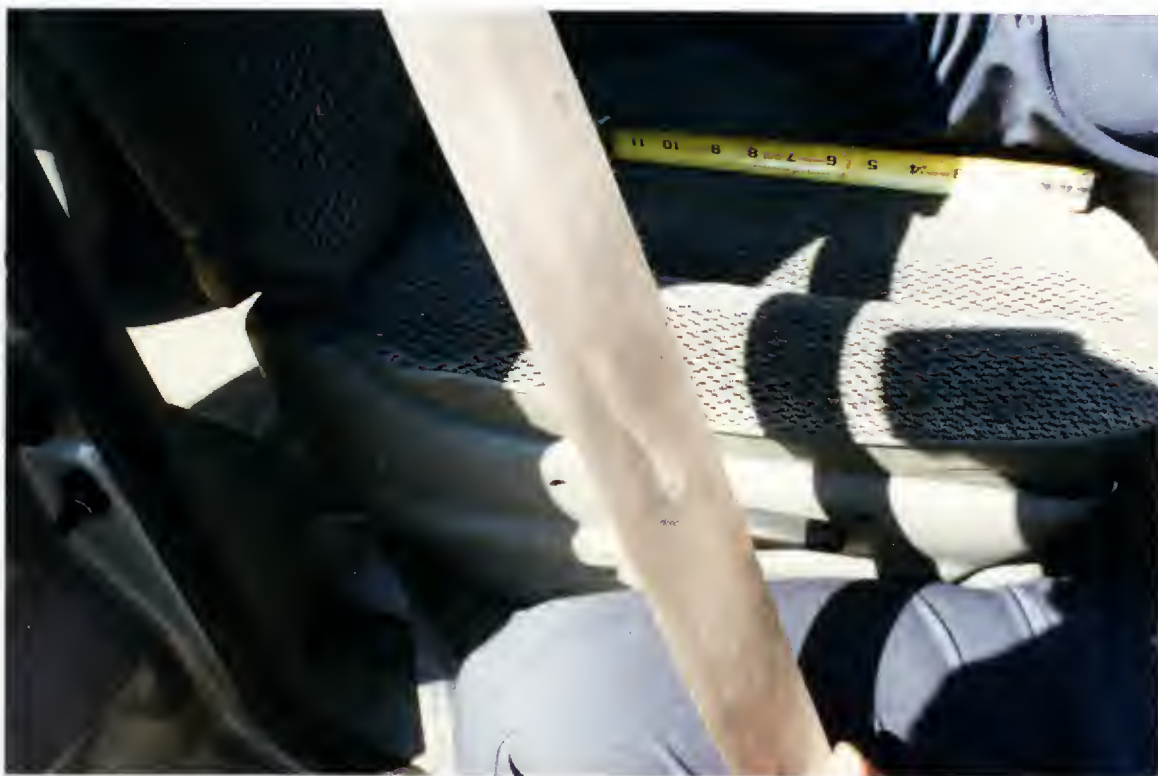
The 5 year old child passenger was seated in the right front position and was restrained by the lap portion of the restraint with the shoulder belt probably positioned behind her back. The right front D-ring was adjusted to the full down position (refer to Photograph No. 85). A faint abrasion was noted on the outboard aspect of the plastic crossbar of the latchplate (refer to Photograph No. 88). There were blood stains noted 7.6-15.2 cm (3.0-6.0 in) outboard of the latchplate on the lap portion of the webbing. There were also eight (8) small blood stains noted on the shoulder aspect of the belt webbing (refer to Photograph N. 87). The stains were located 5.1-15.2 cm (2.0-6.0 in) above the latchplate. These stains probably were deposited after the child rebounded back under the shoulder belt webbing in the later stages of the crash sequence. A fluid spill was also noted on the right front restraint webbing (refer to Photograph Nos. 89-92), however, this did not appear to be related to the crash.

89. View of a fluid spill on the right front restraint webbing.

90. View of a fluid spill on the right front restraint webbing.

91. View of a fluid spill on the right front restraint webbing.

92. View of the fluid spill. Note, this is the reverse side of the webbing.

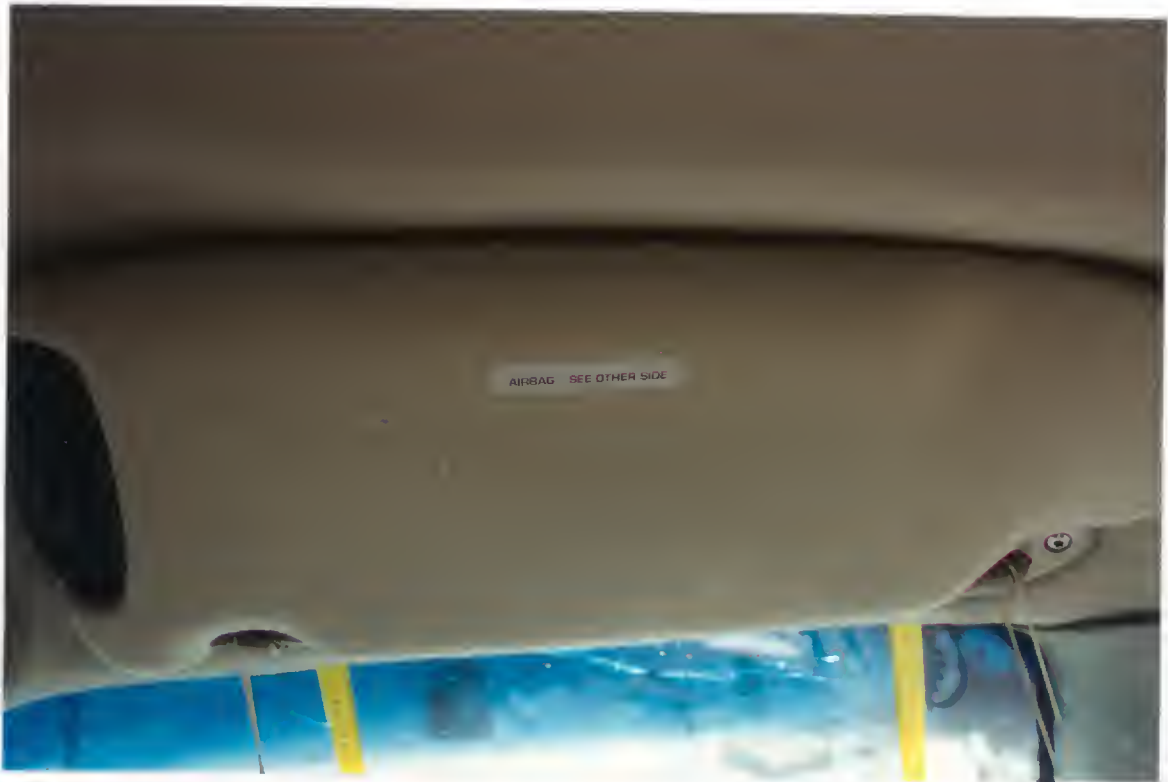
96. View of the right sun visor.

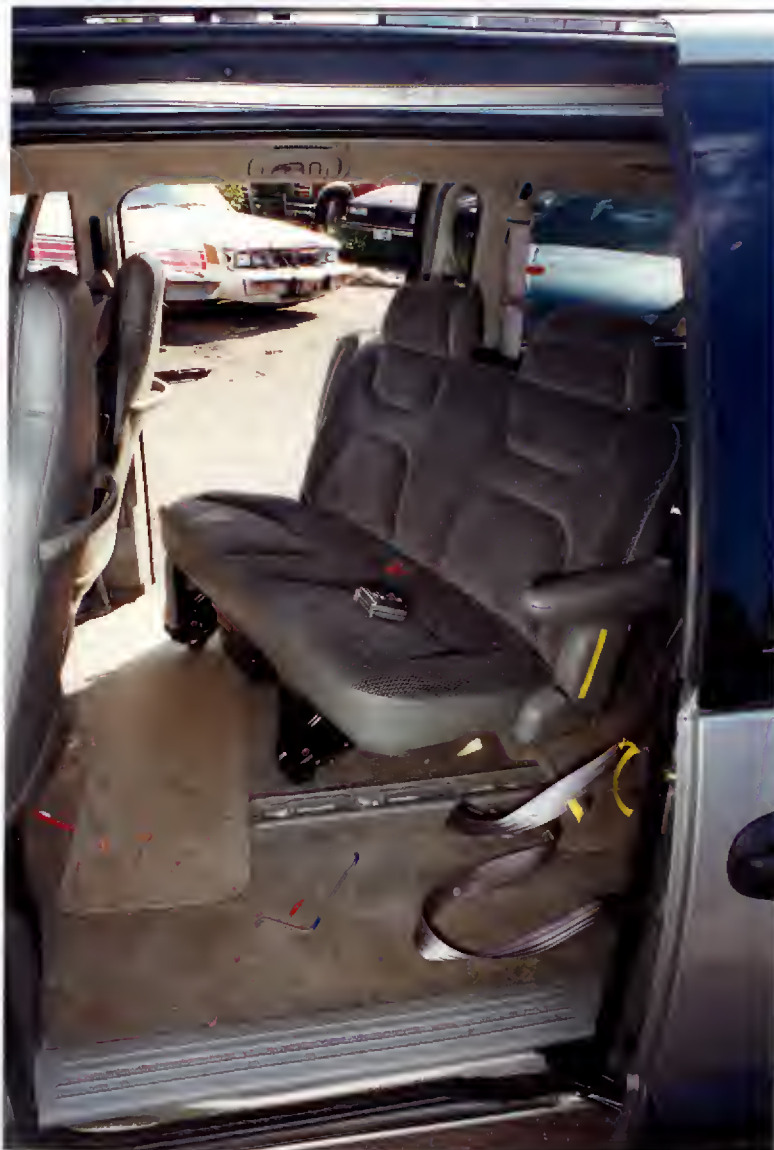
child safety seat on the seat cushion. Abrasions were noted to the shoulder belt webbing and to the plastic extrusion at the seat cushion/seat back juncture. In addition, the loading produced a D-ring transfer to the shoulder belt webbing. This evidence is documented in Photograph Nos. 97-102.

97. Left side view of the second seat of the Dodge Caravan.

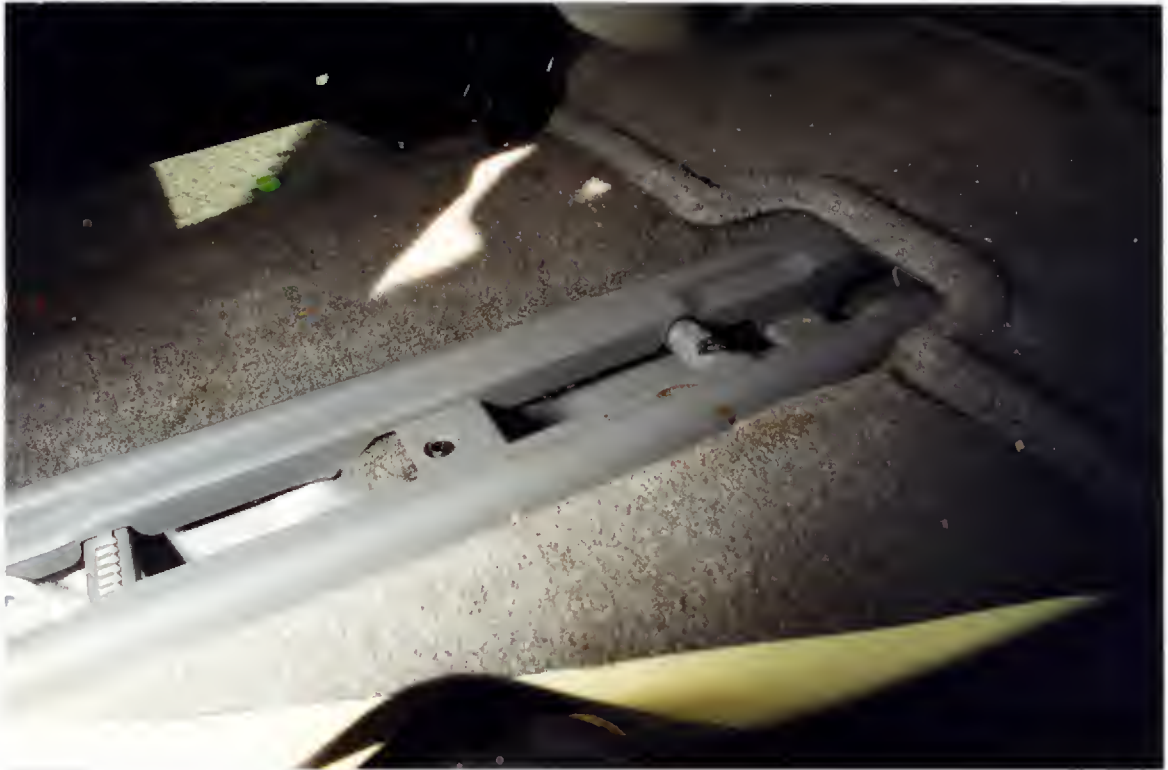
98. View of the second seat's left side floor mount.
